the *American* Surveyor

MARCH 2015

ONE-ROOM SCHOOLS, Aerial Photos, & Hokey Pokey Surveys

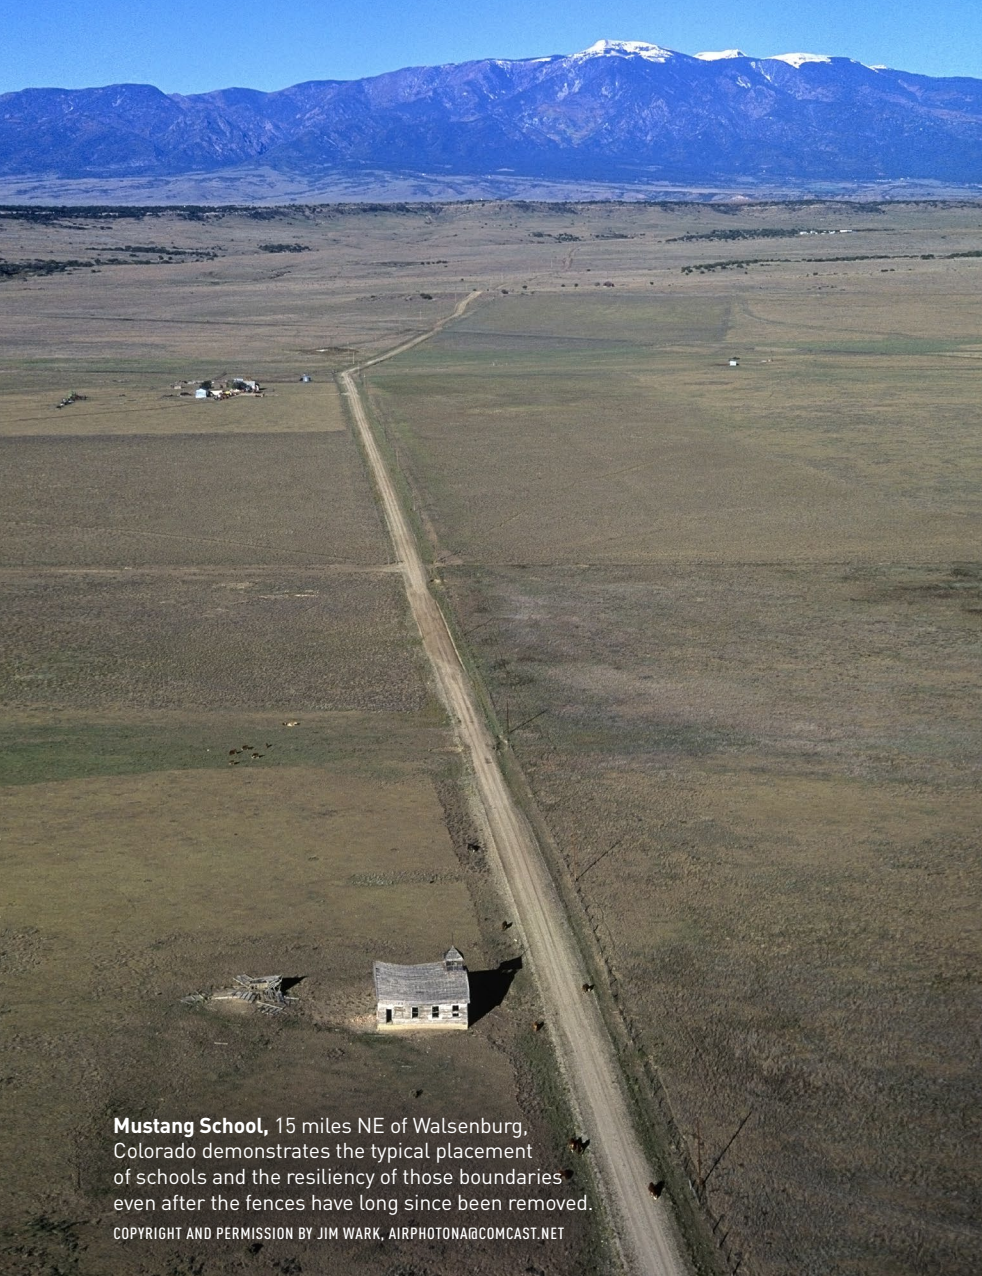
Mustang School, 15 miles NE of Walsenburg, Colorado demonstrates the typical placement of schools and the resiliency of those boundaries even after the fences have long since been removed.

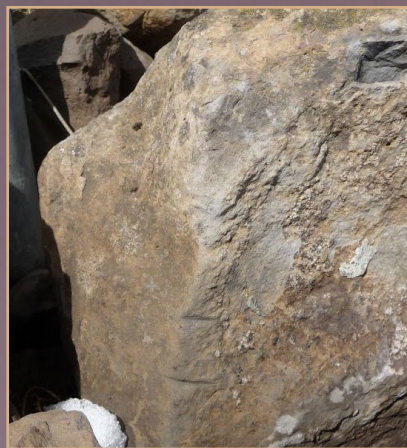
Carl Edwards' Stone. Are these GLO notches or disc notches?

1. The volume of the Edwards stone is only 50% of what was reported in the Field Notes.
2. The stone has two notches, not the three of 1873 record, and these might have been caused by field discing.

3. The two notches are relatively fresh and distinct, whereas the notches on other 140 year old iron rich basalt corner stones in northern Idaho have notches and grooves that are rounded and dimmed, if not disappeared entirely into an outer shell of thick oxide.

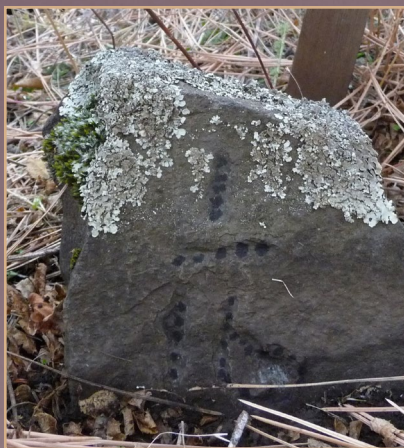
1909 Co. Surveyor's W1/16th Stone. Notice the rounding effect of electrolysis.

7. Contrarily, the 1909 County Surveys that retraced and subdivided Section 24 set a W₁/16th county stone on the south section line which establishes

that line as cardinal. Therefore the west line of the SW₁/₄ must be longer than reported in 1897. Nine of the ten surveys performed in this area are in agreement on this point.

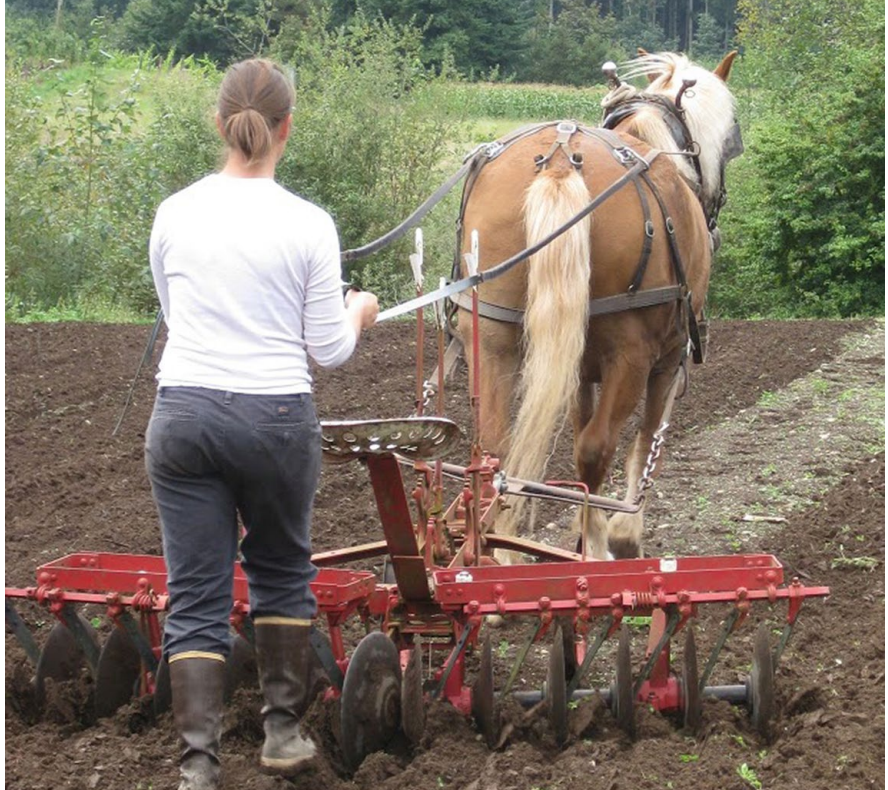
Erin & Sam notching stones with a disk.

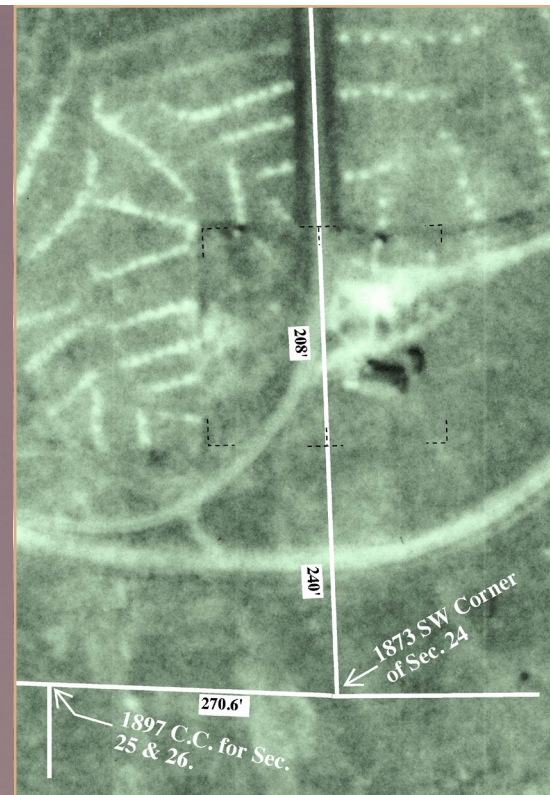
Wet-Drum Scanned Image Of Same Photo.

On the left is the enlarged contact print of the July 20, 1946 USDA photo, notice...almost nothing. Whereas, in the drum scan to the right you can even see trails running from the back door of the school building to the two outhouses. Though you can't see the fences themselves you can see the edge of cultivation of adjoining fields on the north and west. We identified lone pine trees on the 1946 aerial photographs and used these to developed photo scales north-south and east-west and

drew 104' x 208' boxes. They fit. A 1921 highway drawing shows the south edge of the school building to be located 35' north of the south school boundary. Check. The section corner position developed from the 1909 County Survey is also in general agreement, plus or minus 30' in northing. Equally significant is the lack of conveyors and stockpiles.
